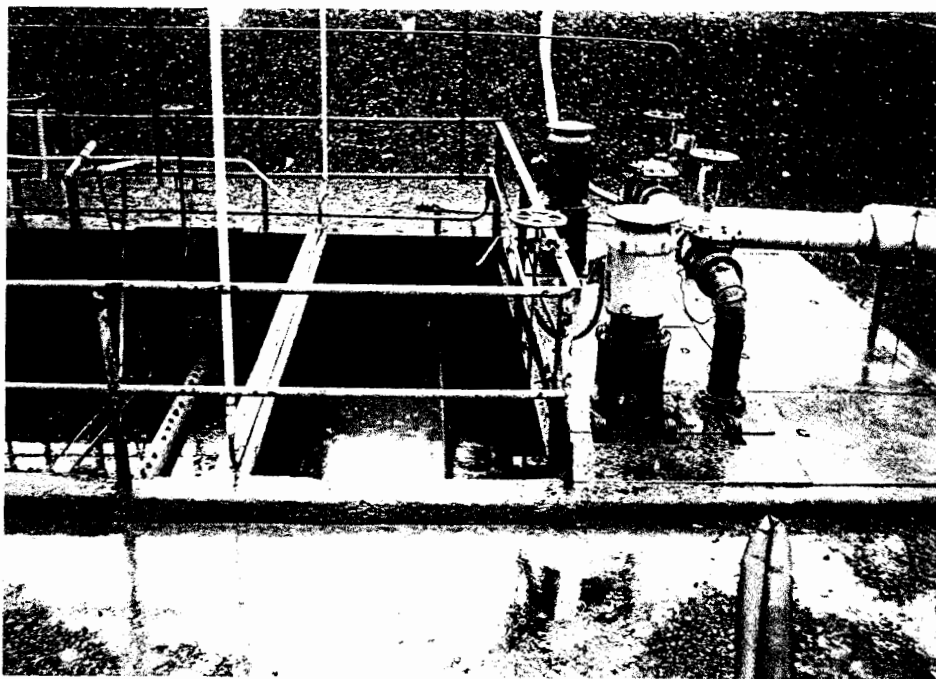
63.1 1A Oil/Water Separator. View facing east toward the middle section of the separator. Note the oily accumulation on the soil around the unit.

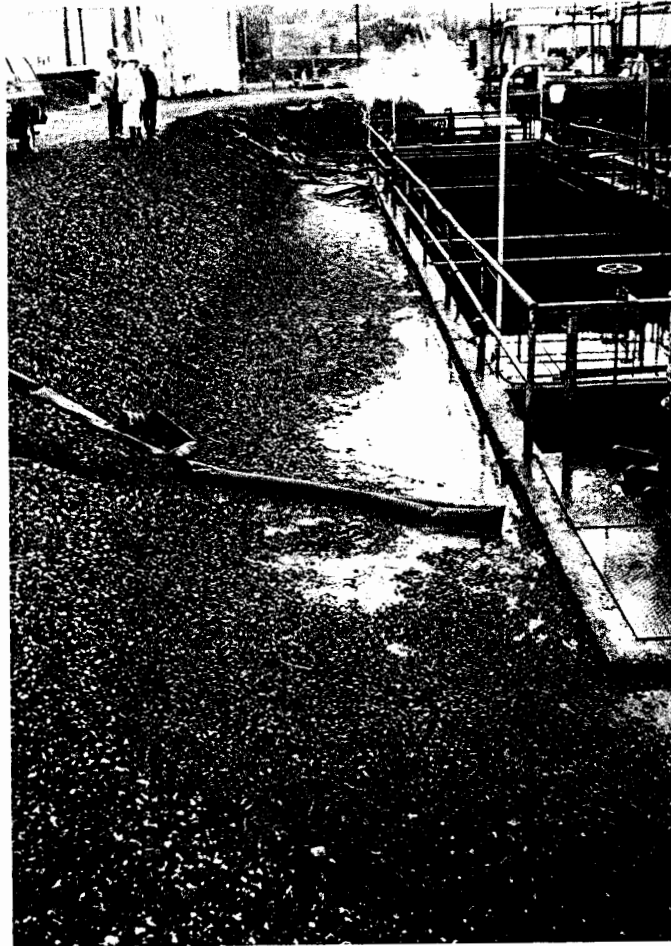
63.2 1A Oil/Water Separator. View facing northeast toward the weir and pump for the separator. Note the heavy oil accumulation on the soil around the unit.

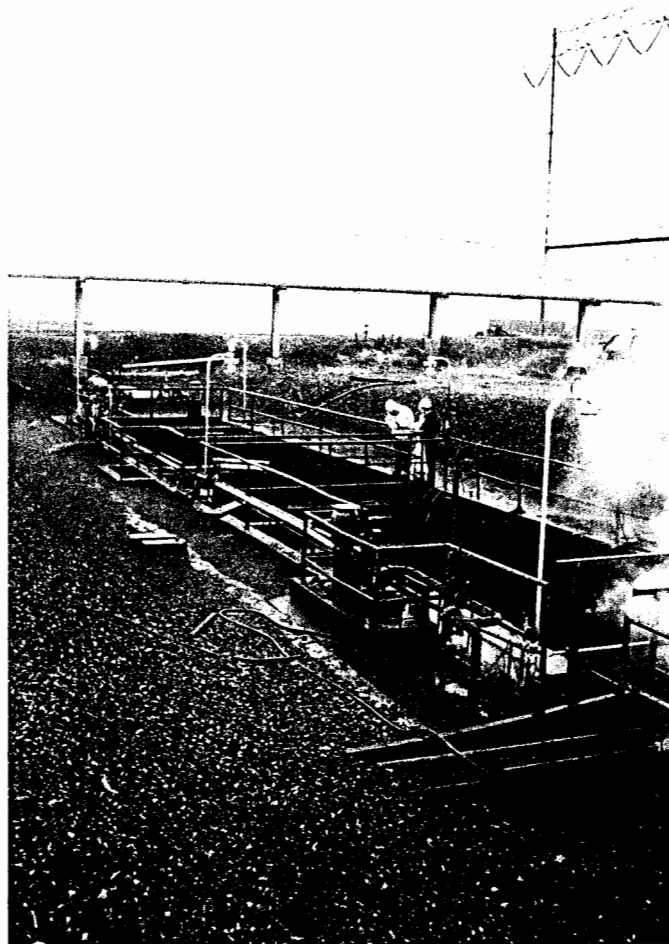
63.3

1A Oil/Water Separator. View facing northwest along the southwest side of the separator. Note the stain line along the bottom of the gravel containment wall to the left of the unit.

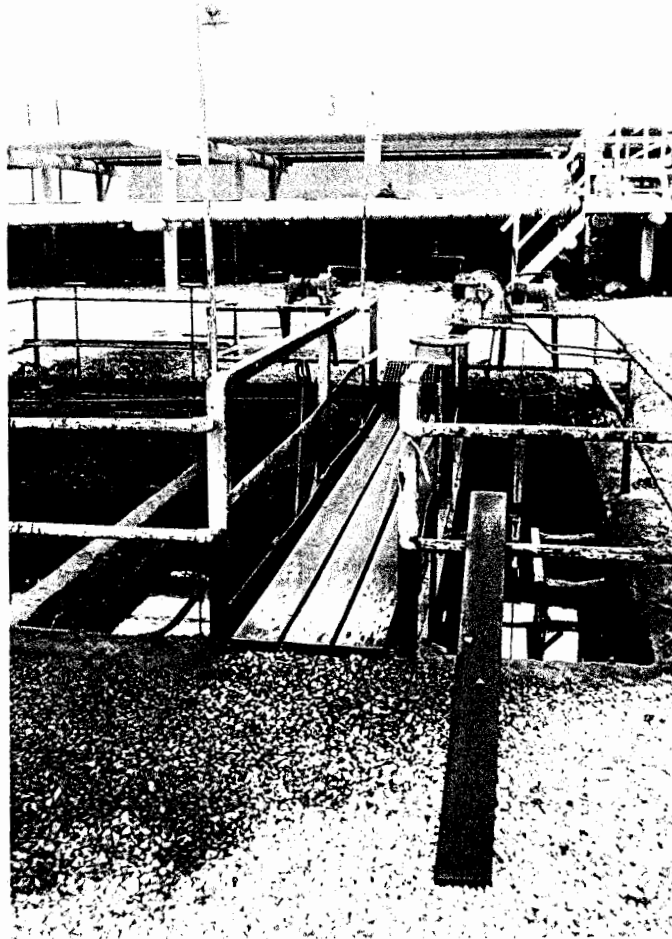
65.1 1C Oil/Water Separator. View facing south. Note the heavy staining on the unit and surrounding areas.

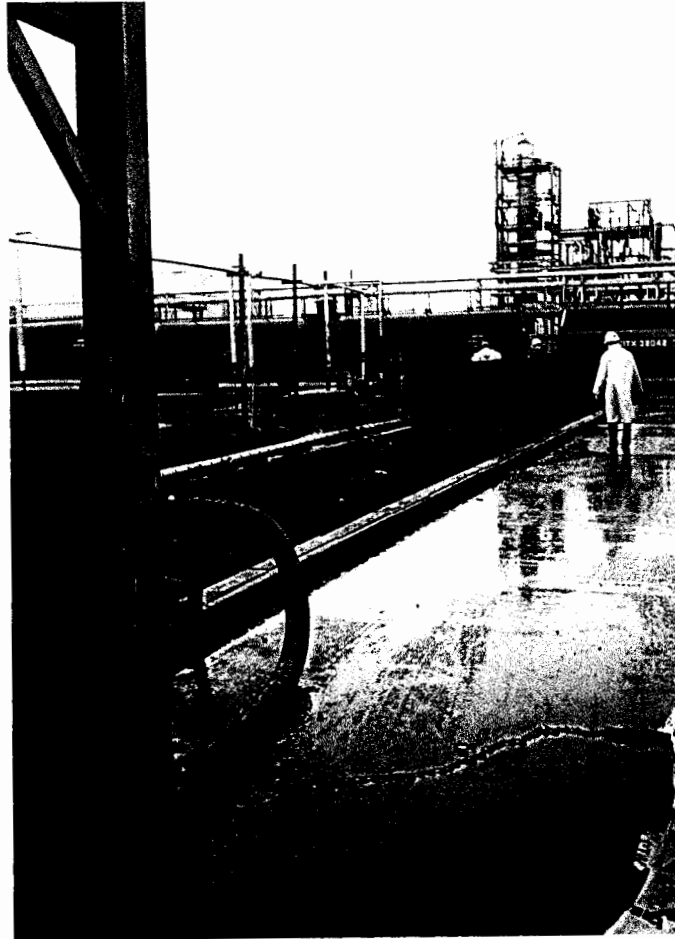
65.3 1C Oil/Water Separator. View facing west toward the skimmer at the south end of the separator. Note the condition of the unit and the oil on the water.

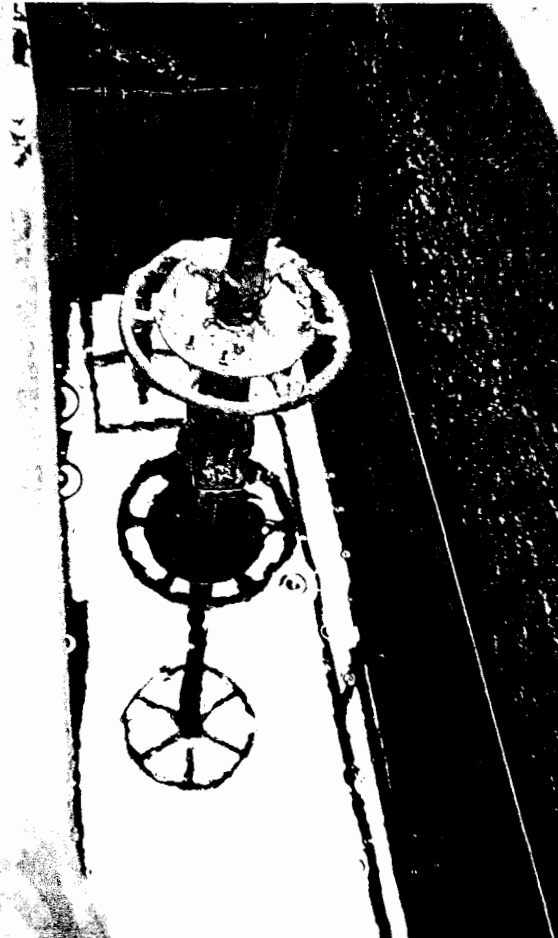
66.2 1D Oil/Water Separator. Close-up view of strainer at the north end of the separator. Note the oil saturated condition of the debris collected in the screen area.

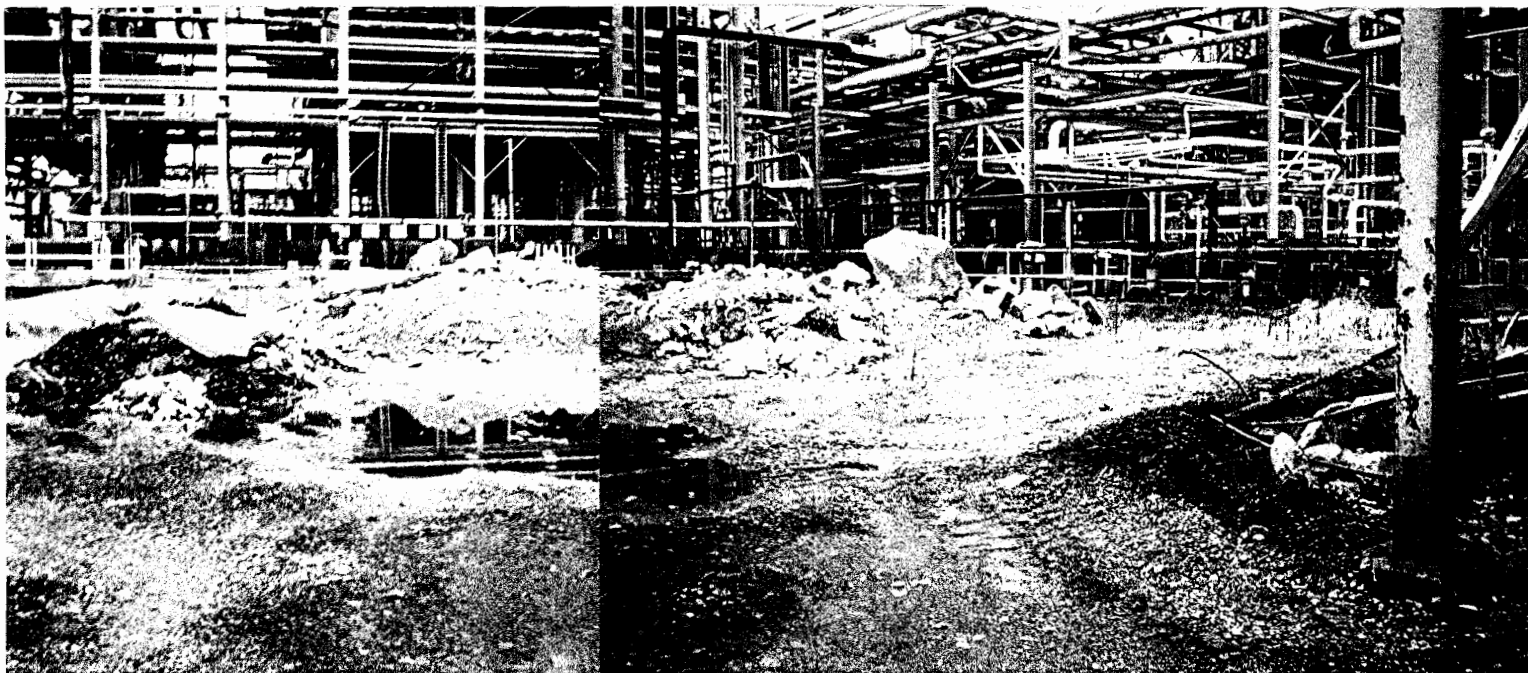
70.6-79.6 9 and 14 Oil/Water Separators. View facing west toward west end of the 9 Separator showing the demolished compartments 9A, 9B, and 9C. Note the heavy oily accumulation.

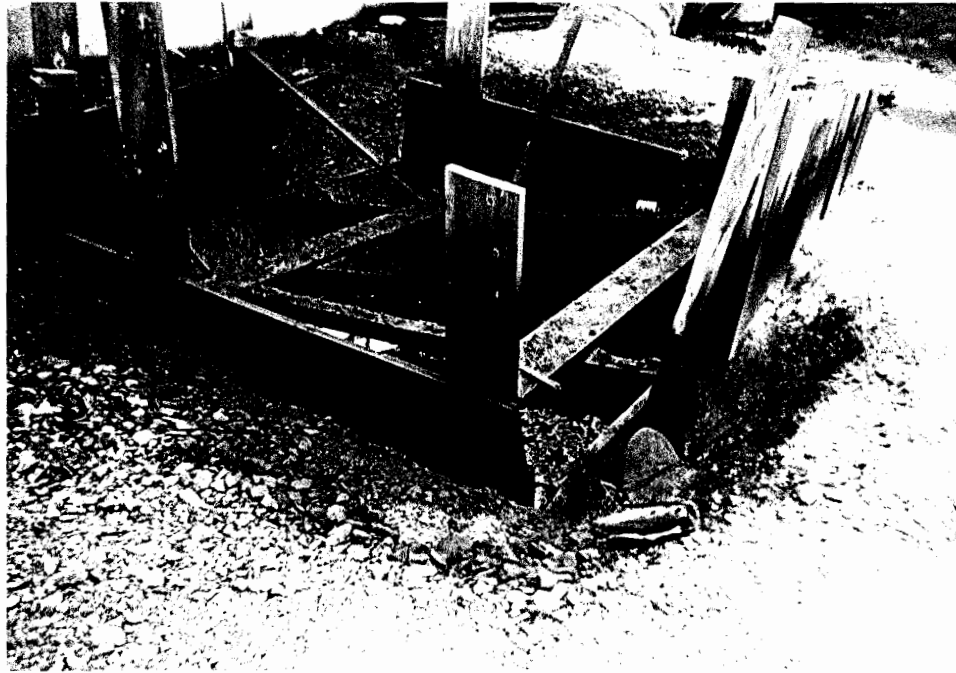
- 80.1 Discharge Pipe and Excavation at 9 and 14 Oil/Water Separators. View facing west toward a wastewater line (the large black corrugated pipe), through which the effluent from the 9 and 14 Oil/Water Separators (SWMUs 70 - 79) flowed to the Middle Creek Surface Drainage System (SWMU 96). The excavation pit in the foreground has been abandoned. Note the heavy staining along the pipeline and surrounding the pit. The pit is approximately eight feet square and could be as deep as ten feet.

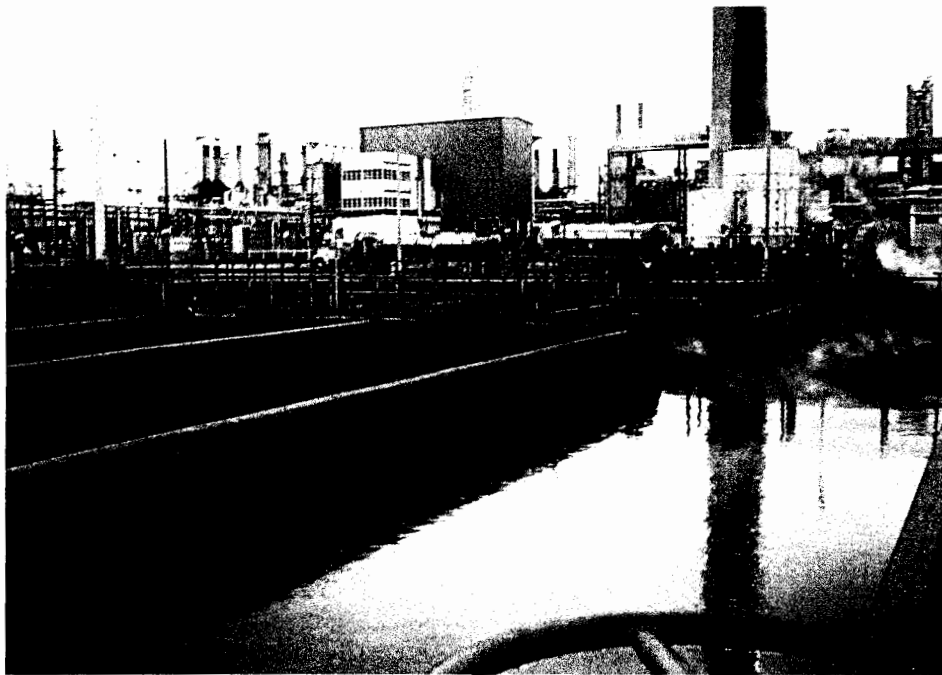
87.1-94.1 15 Oil/Water Separators. View facing northeast toward the east end of the separator. Note the oil accumulation in the unit.

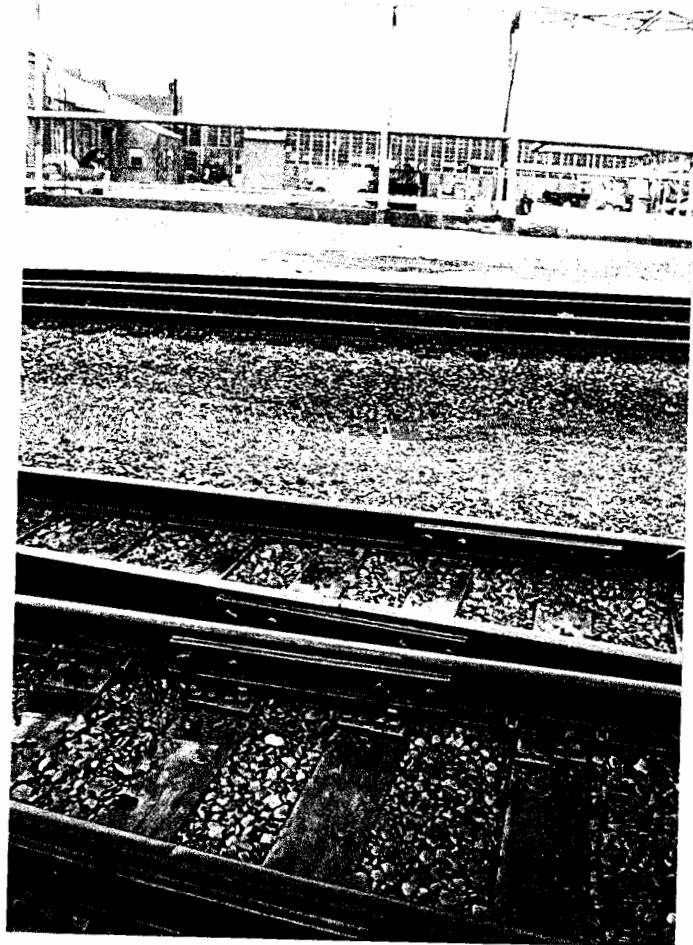
95.7 Combined Process/Storm Sewer System. View facing northeast toward the railroad tracks just south of the 16 Oil/Water Separators (SWMU 84-86) where several sewer drains are visible in the depressions (arrows). Staining is apparent around the drains from sewer backup.

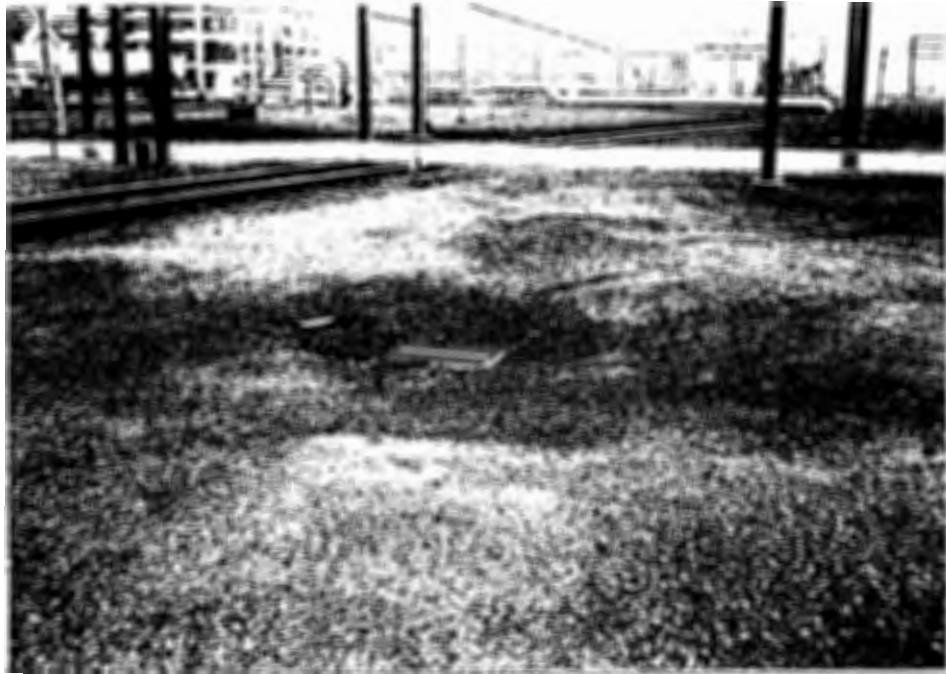
95.8

Combined Process/Storm Sewer System. Close-up view of the sewer drains between the railroad tracks. The apparent staining is due to sewer back-ups during high precipitation periods.

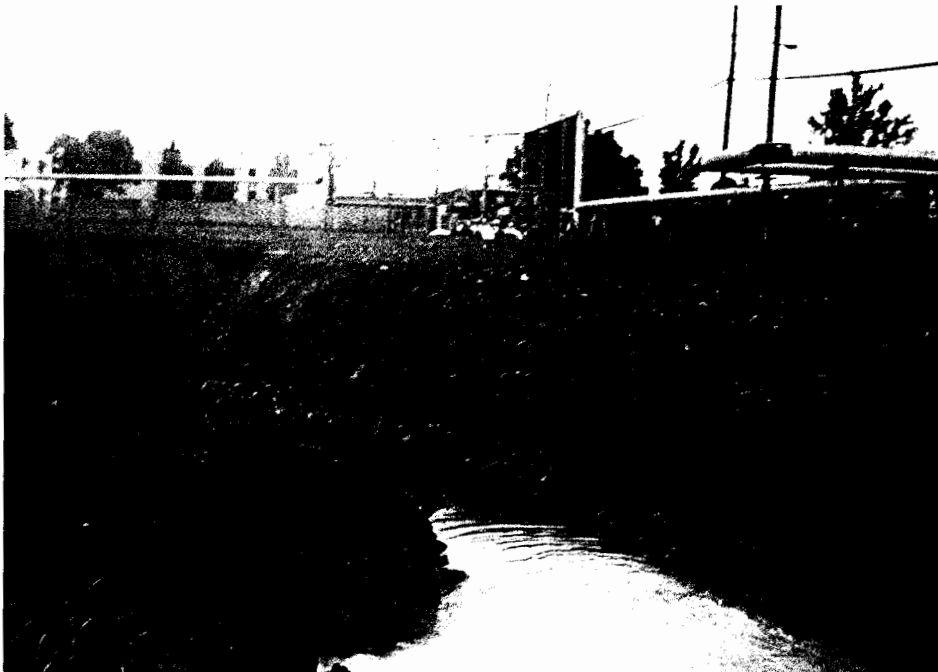
- 96.1 Middle Creek Surface Drainage System. View facing north toward the final discharge point for the 10 Oil/Water Separators (SWMUs 81 - 82). The separators discharge into the Walker's Run portion of the Middle Creek Surface Drainage System (SWMU 96). Note staining on surrounding gravel area.

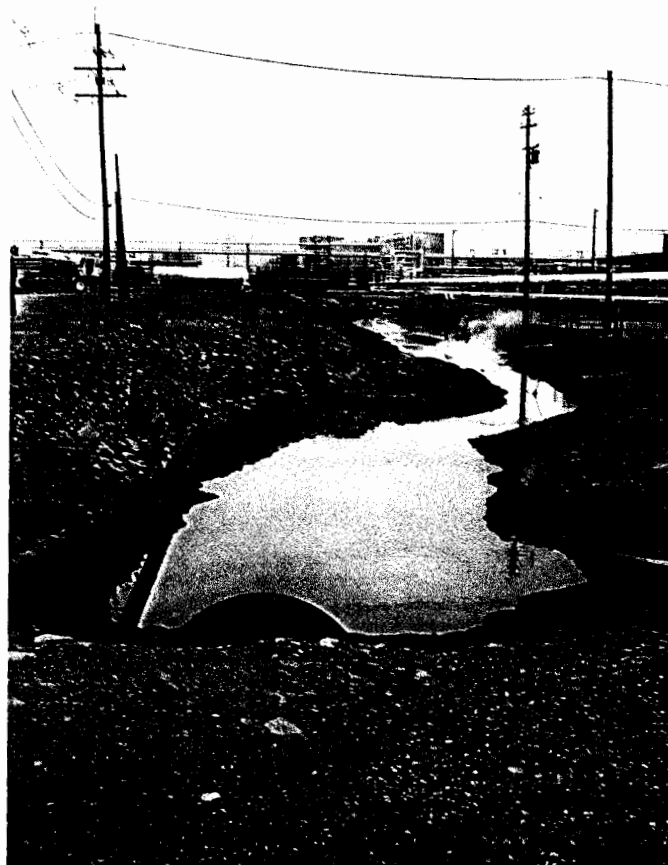
- 96.2 Middle Creek Surface Drainage System. View facing north toward receiving area in Middle Creek for discharge from the 10 Oil/Water Separators (SWMUs 81 - 82). Note heavy staining along creek banks.

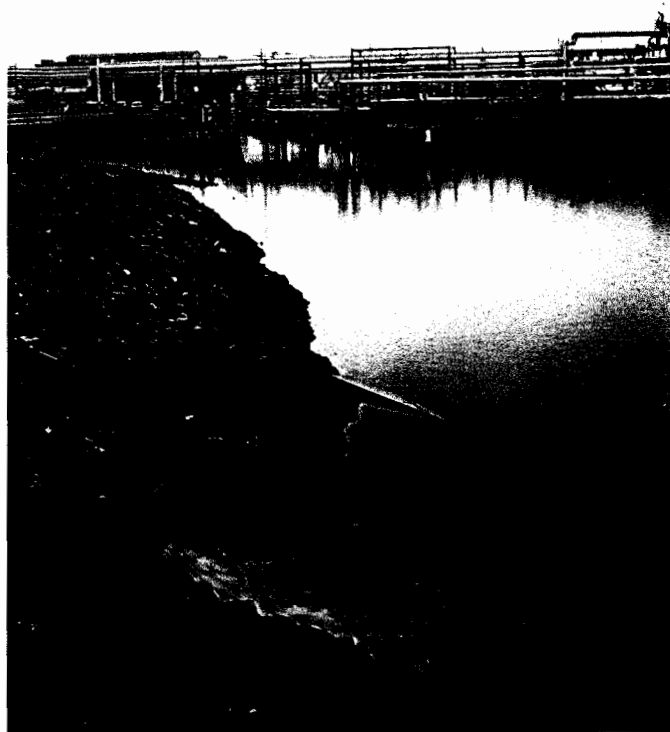
96.7 Middle Creek Surface Drainage System. View facing southwest toward the east (upstream) side of the dam for Middle Creek. Note the heavy staining in the creek and surrounding areas. The overhead pipes are to the DELCORA POTW.

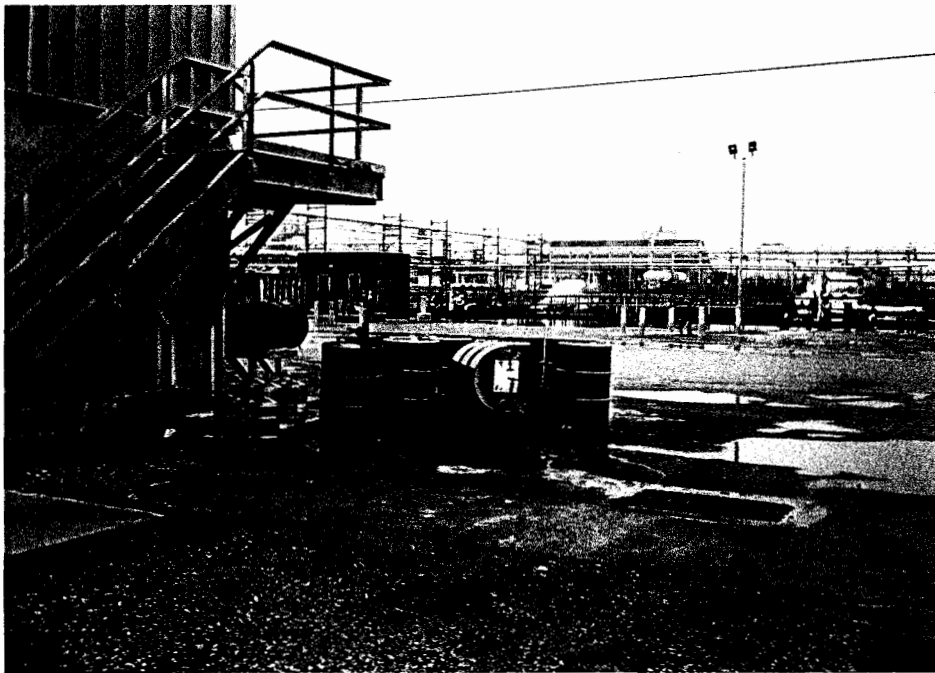
97.1 Product Drip Collection Areas. View facing north of the drip collection area for oils used at the Solid Waste Facility. Note extensive oily staining on concrete and soil under the drums.

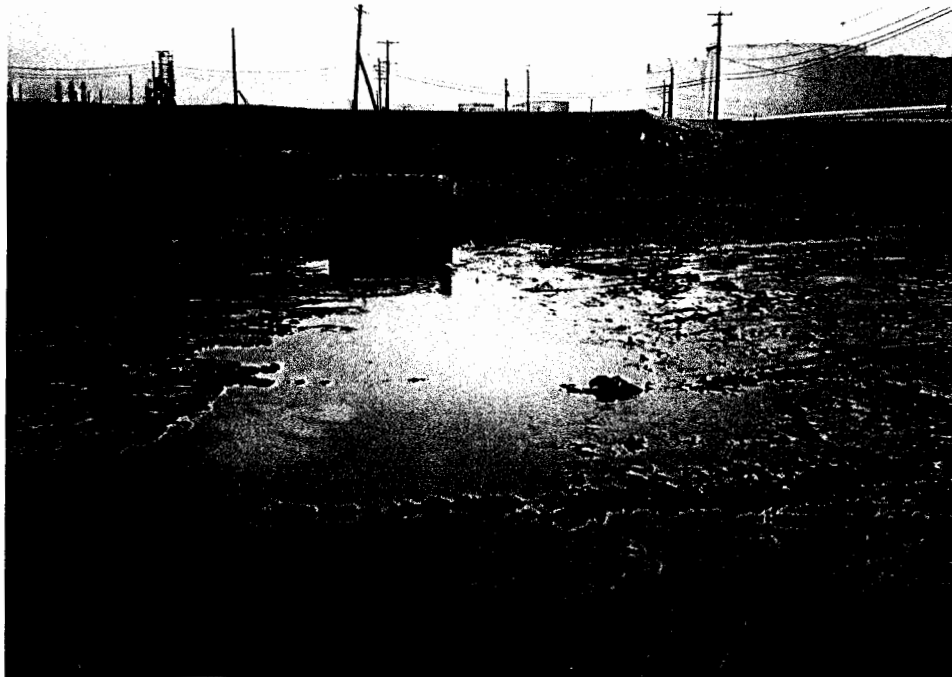
- 98.2 Aboveground Tank Containment Areas. Close-up view of the leaking pipe from Tank 10. Note the heavy oil accumulation in the area which drains to the containment area sump connected to the Combined Process/Storm Sewer System (SWMU 95).

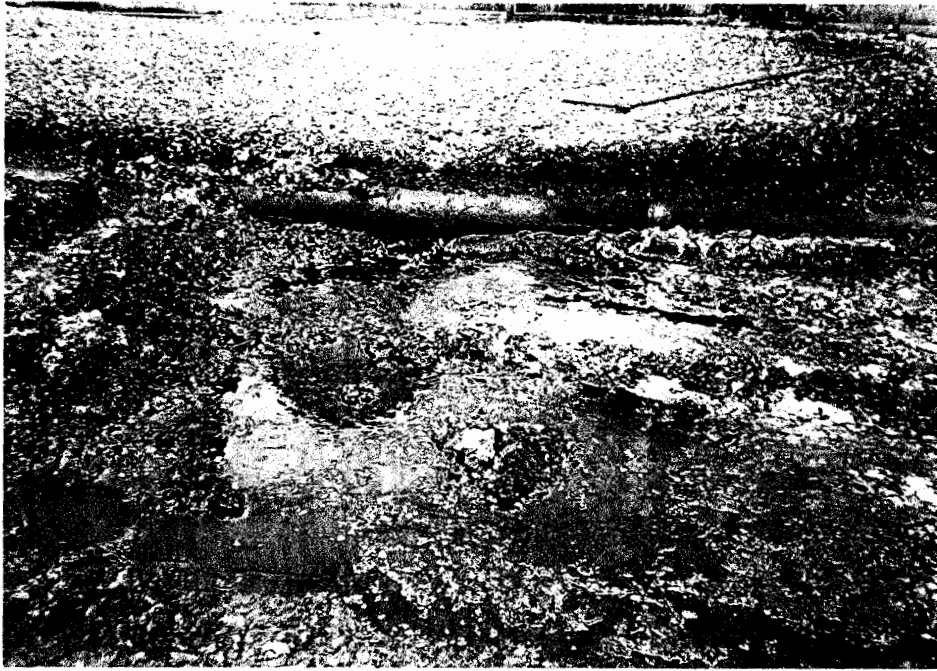
- 98.3 Aboveground Tank Containment Areas. View facing south to southeast toward the receiving sump for the containment area surrounding Tank 10. Note the heavy oil accumulation in the containment area.

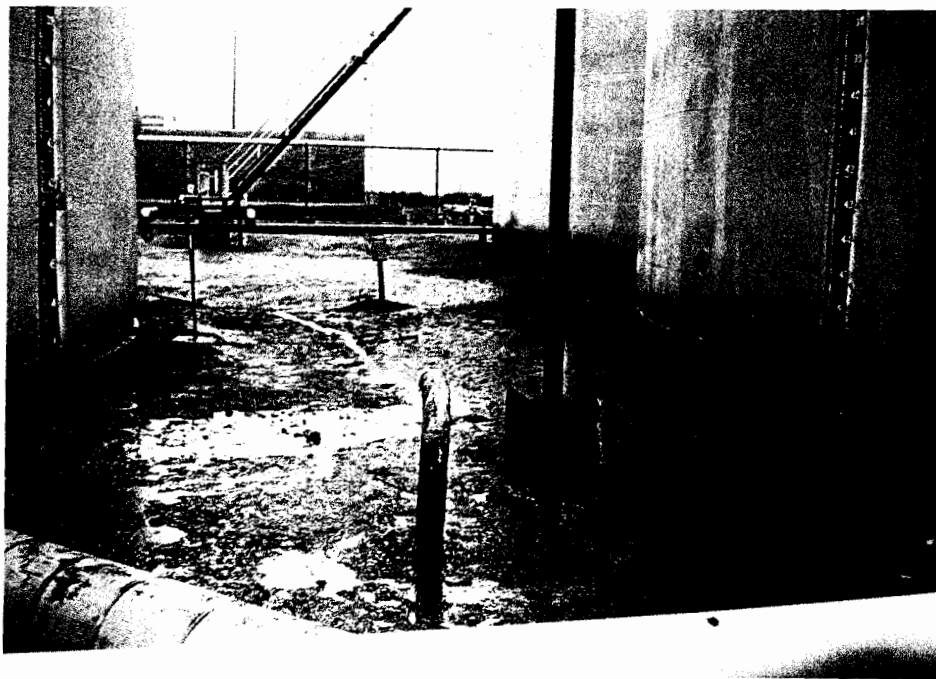
- 98.4 Aboveground Tank Containment Areas. Close-up view of a pipe at the base of Tank 10 which may be contributing to the leakage in the containment area.

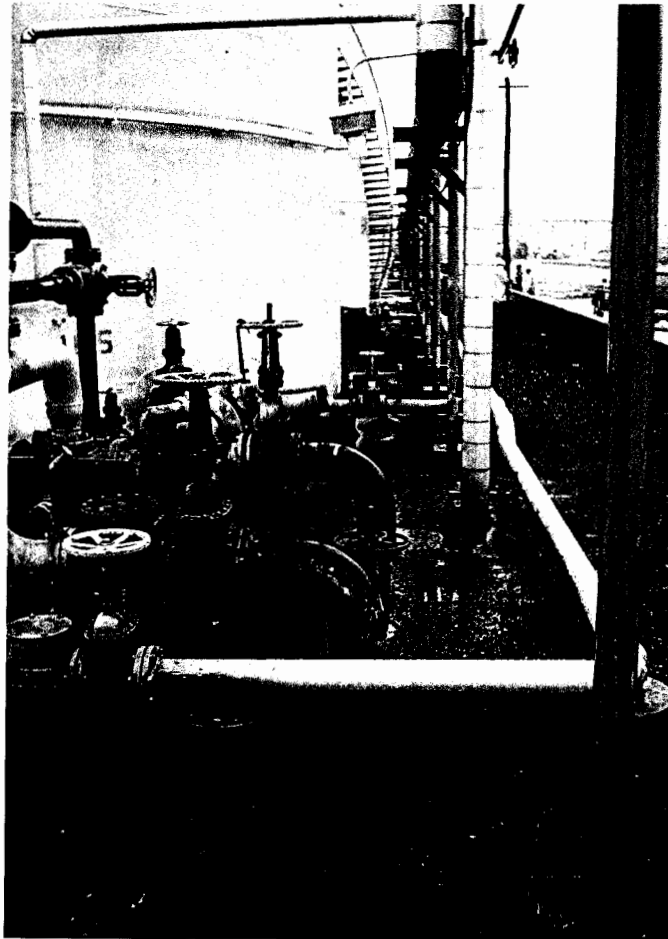
- 98.5 Aboveground Tank Containment Areas. View facing north toward the containment area for tanks located within the H-13 Tank Farm. Note the oil saturated condition of the ground surface. This is typical of the older tank farms at the facility.

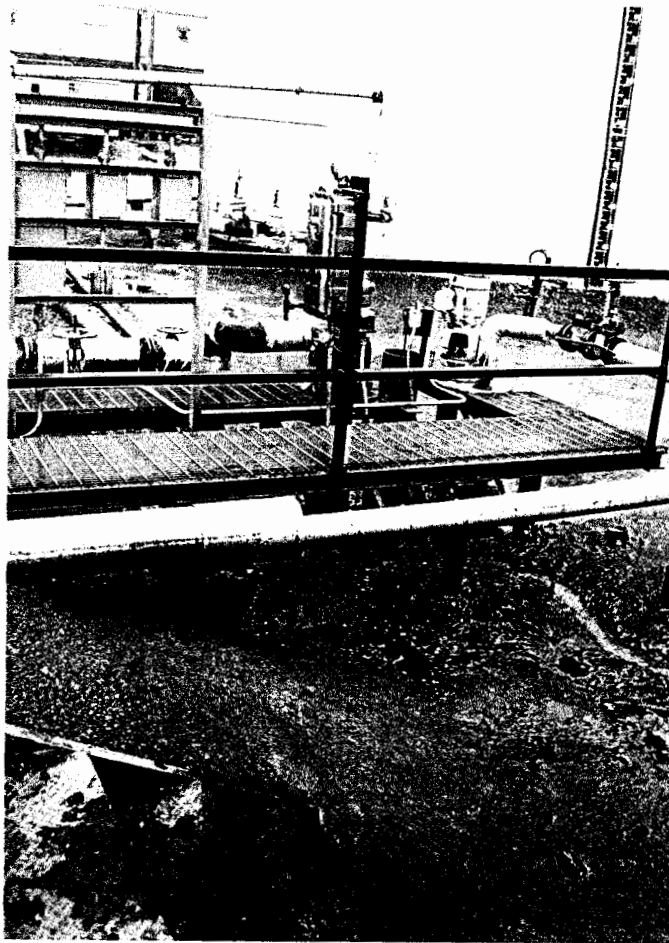
98.7

Aboveground Tank Containment Areas. View facing east toward a portion of the containment area for tanks in the H-13 Tank Farm. Note the heavy staining and rusting condition of the tank bottoms.

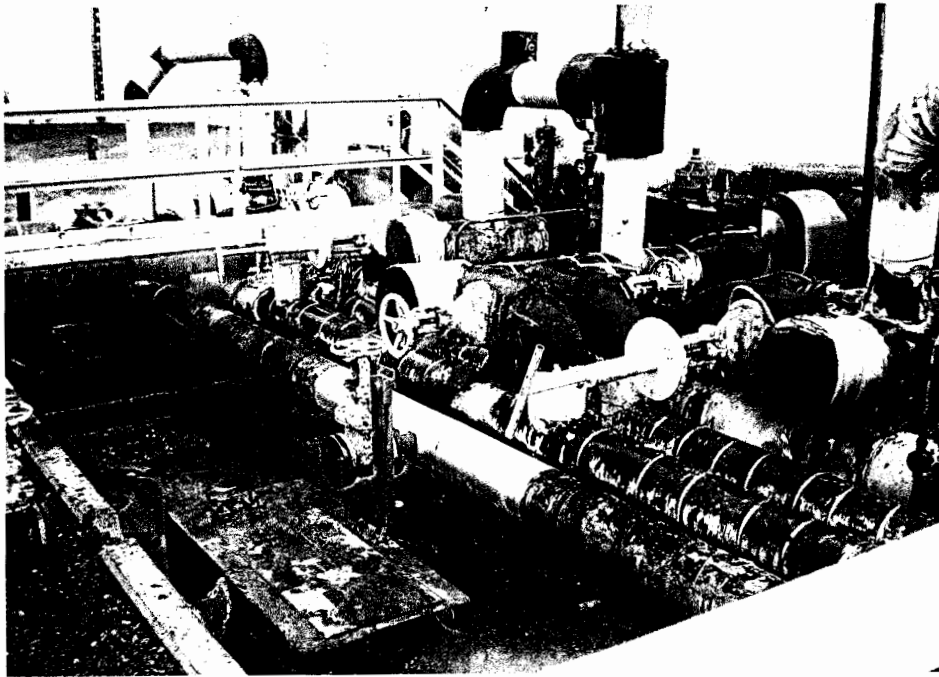
98.8 Aboveground Tank Containment Areas. View facing west toward the slop oil pump for the containment area for the H-13 Tank Area. Note the oil saturated condition of the ground surface.

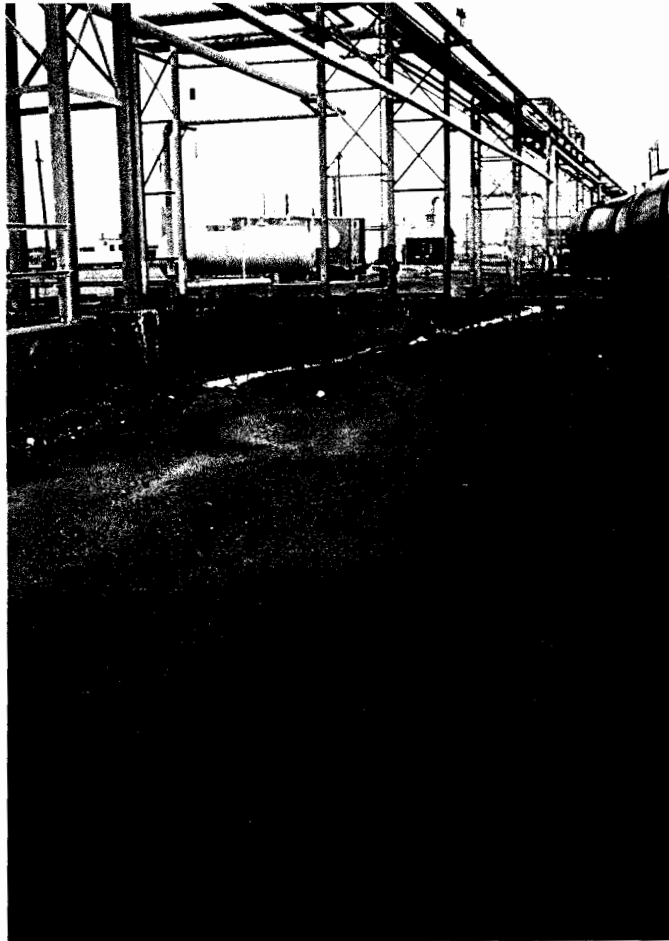
- 98.12 Above-Ground Tank Containment Areas. View facing south toward an old containment area for a slop oil tank. The tank was recently removed. Note the oil saturated conditions on the ground surface.

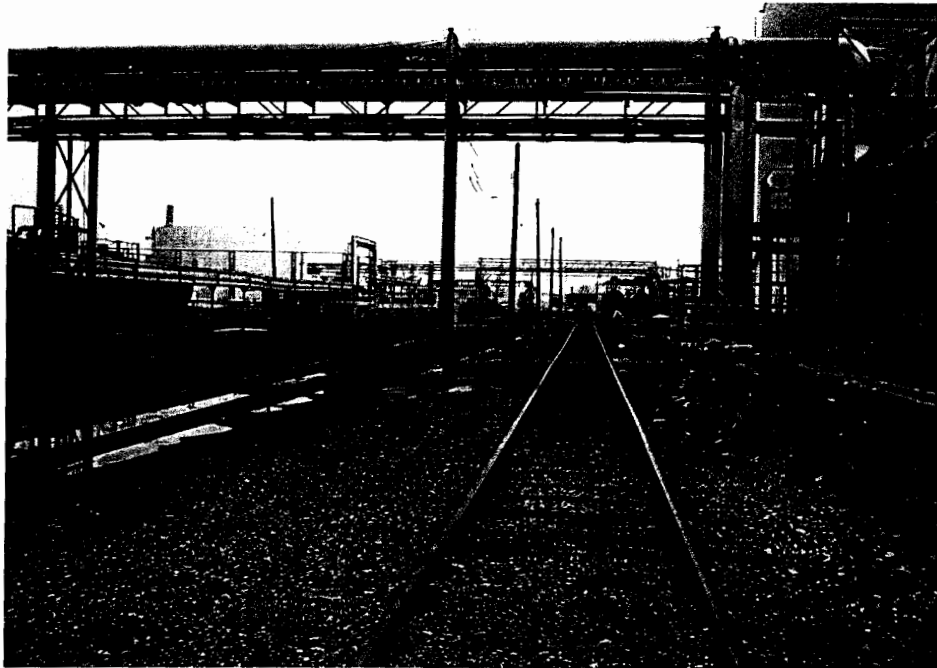
99.1

Rail Car Loading/Unloading Areas and Associated Tracks.
View facing east of the railroad tracks near Middle Creek Road. Note the heavy oil staining in the area, due to drains in the area which back up and deposit oily water.

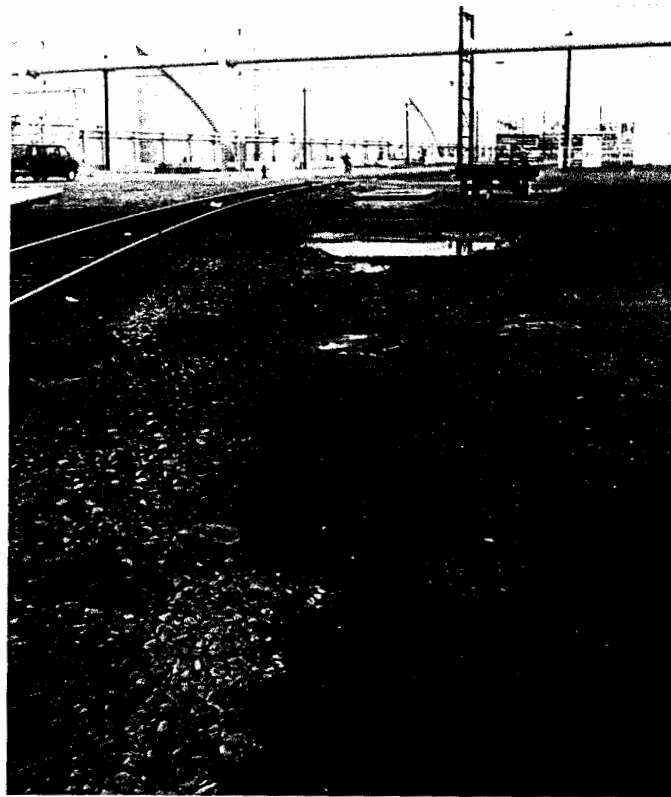
99.2

Rail Car Loading/Unloading Areas and Associated Tracks.
View facing east along rail line associated with the rail car area located to the east of Hewes Avenue. Note the oil saturated conditions of the surrounding ground surface.

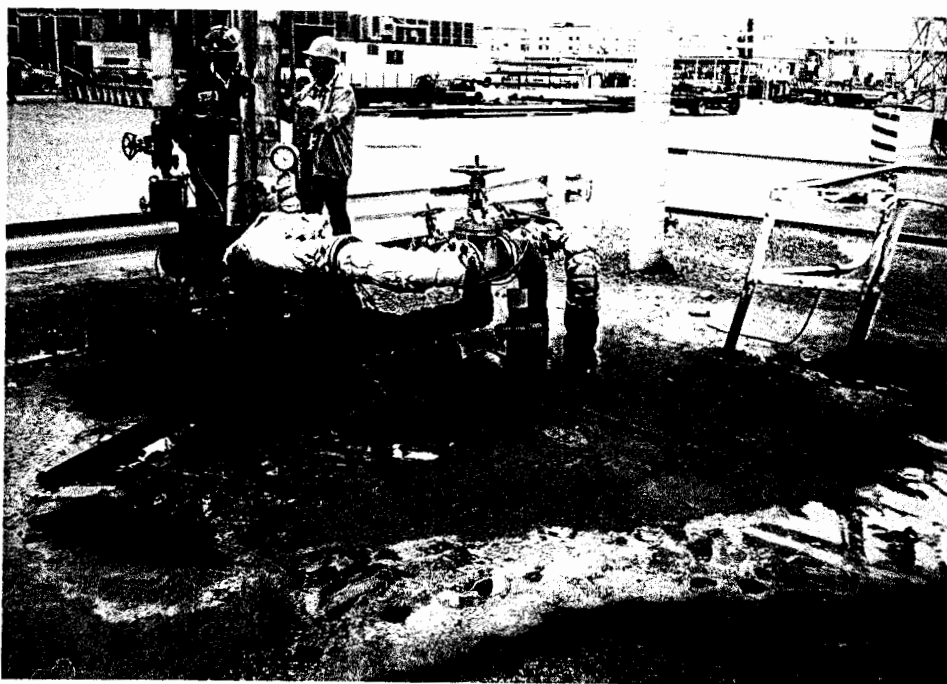
A.2 Stained Refinery Areas. View of north side of Tank No. 32. Note the spillage and the lack of containment for the tank. Spillage may be from valve system.

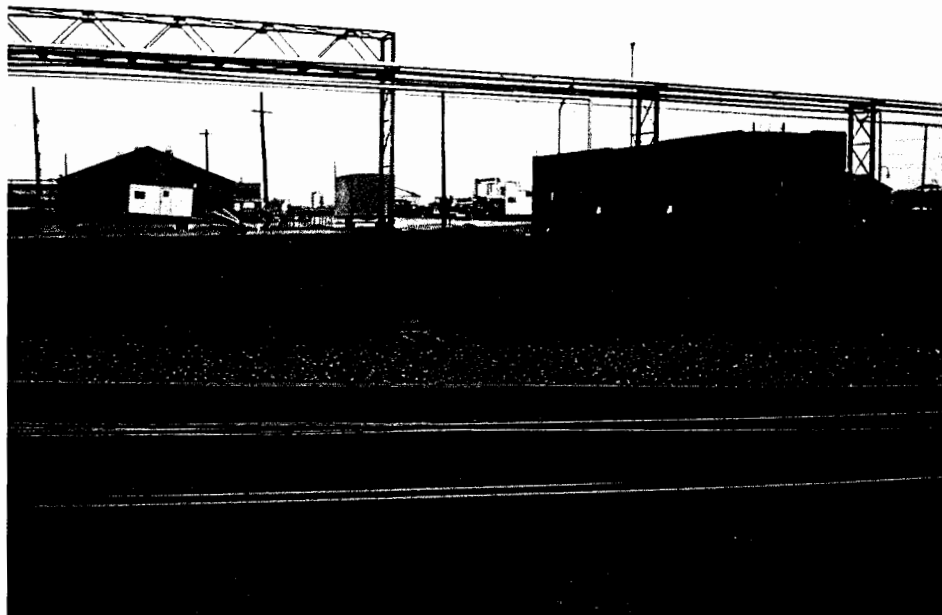
A.3 Stained Refinery Areas. View facing north toward a pump area located to the northwest of the 1F Oil/Water Separator (SWMU 68). Note the heavy spillage and stains in the area.

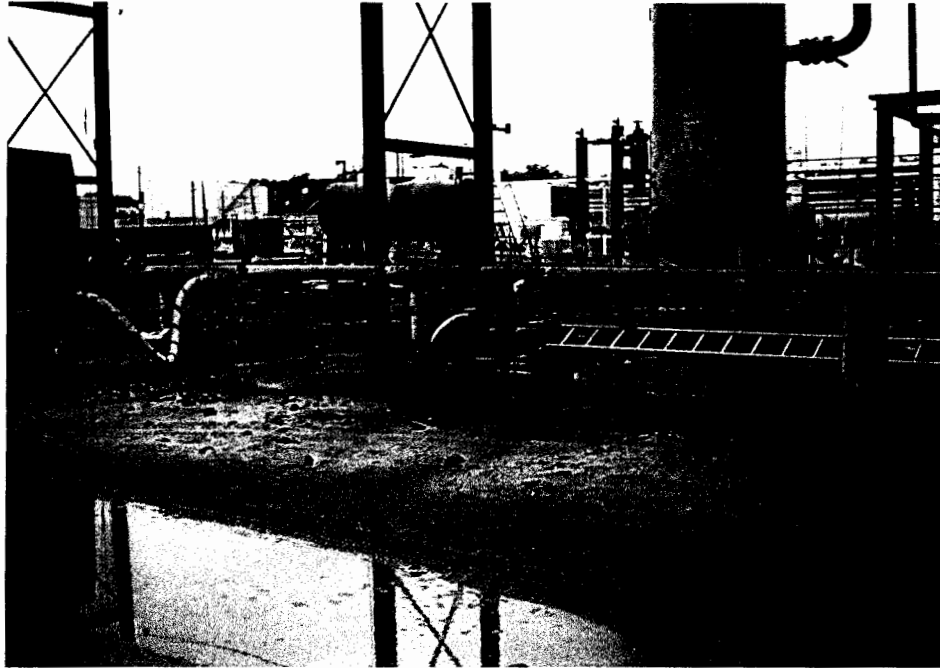
- A.4 Stained Refinery Areas. View facing south toward an area of stained soil that extends from the brick pump house to the sewer drain visible on the far side of the railroad track (SWMU 95). The brick building is the pump house for the 16 Oil/Water Separators (SWMU 84-86), which are visible in the far right corner of the photograph. During the VSI, the stained area (which is not clearly visible in the photograph) appeared to be the result of a spill or overflow near the pump house.

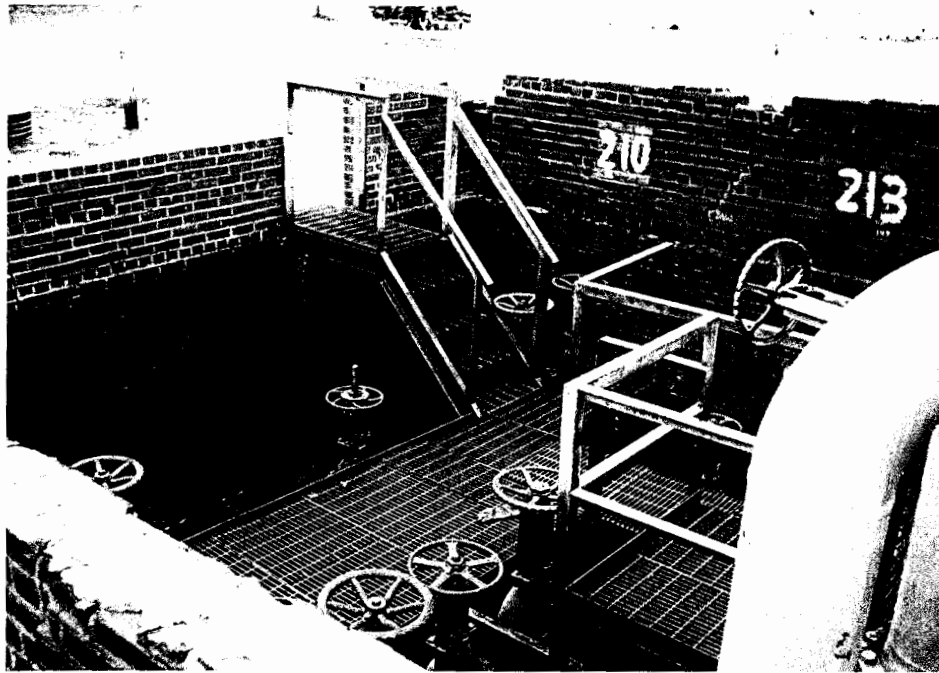
A.6 Stained Refinery Areas. Close-up view of oil saturated area along side of Tank 32 located south of Slop Oil Tank 132 (SWMU 59). Note stains leading to grated drainage area (SWMU 95).

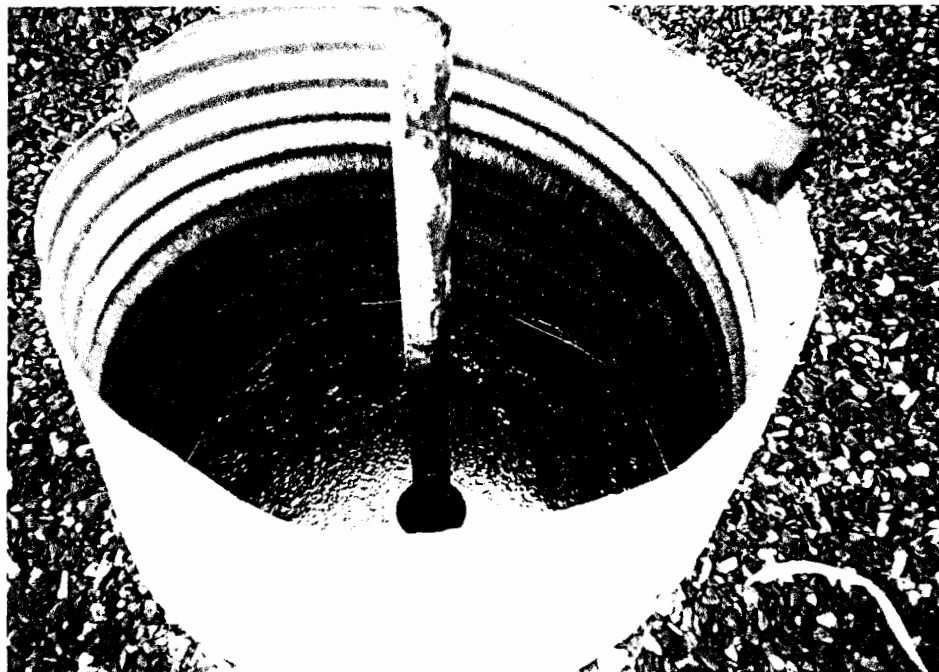
- B.1 Underground Transfer Lines. View looking down into a valve pit for transferring product through the underground lines to and from the tanks located in the tank farm which feeds the 1A Oil/Water Separator (SWMU 63). Note the cracks in the wall and staining on the walls which indicates the pit fills up with water and oil.

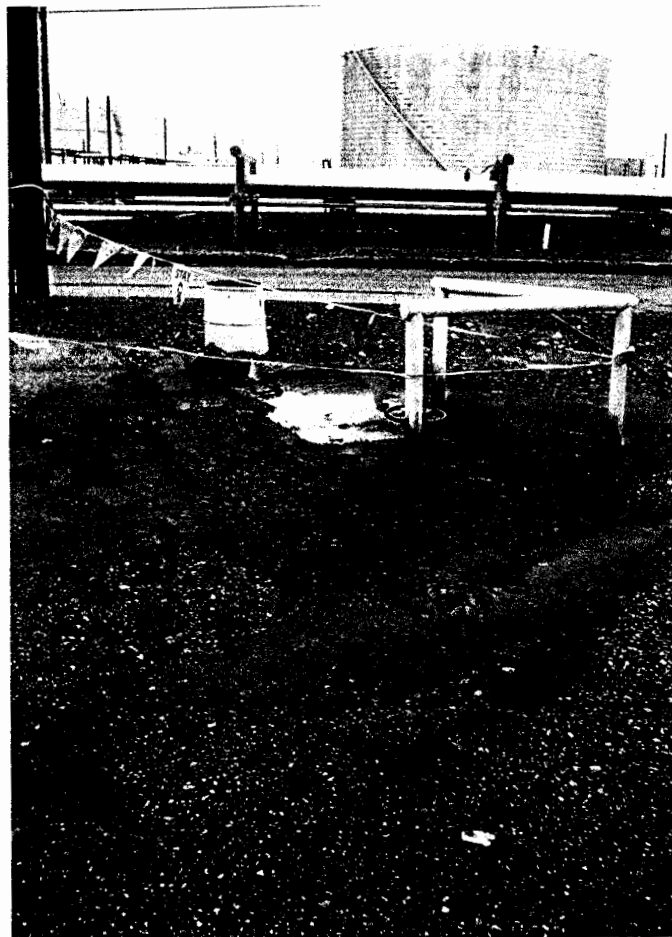
- B.2 Underground Transfer Lines. View looking down into a valve box located at the north Tank Farm. Several of these boxes were seen in each of the tank farms at the facility. Note the oily material.

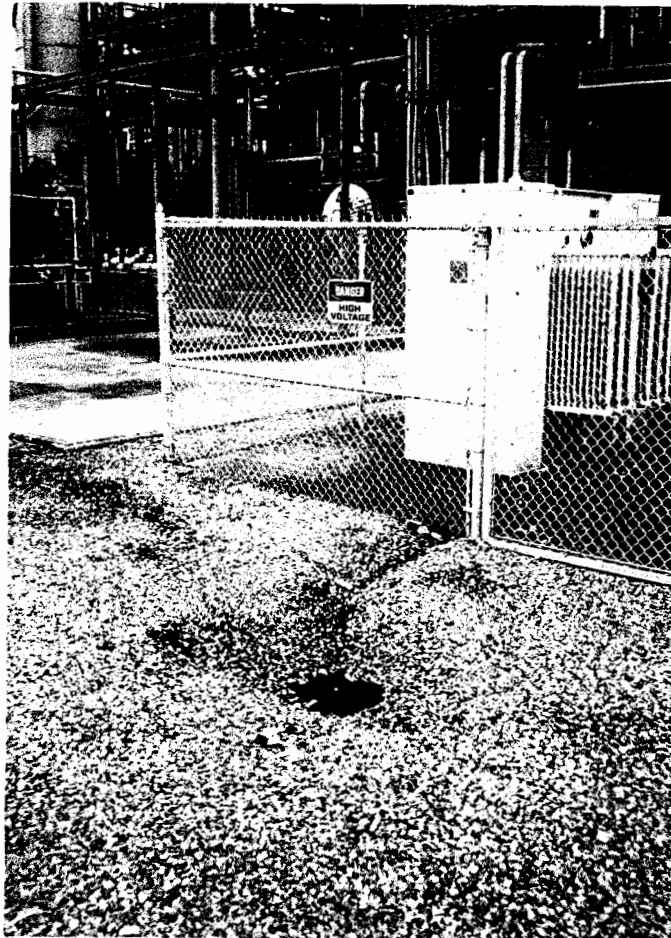
F.1 8-C Plant PCB Transformer Area. View facing southwest toward PCB transformer near 8-C Crude Unit just north of SWMU 42. Note staining leading to storm sewer drain.
